Wasp

WPL406: label feed problems, grinding noise, print quality problems (print head not latched)

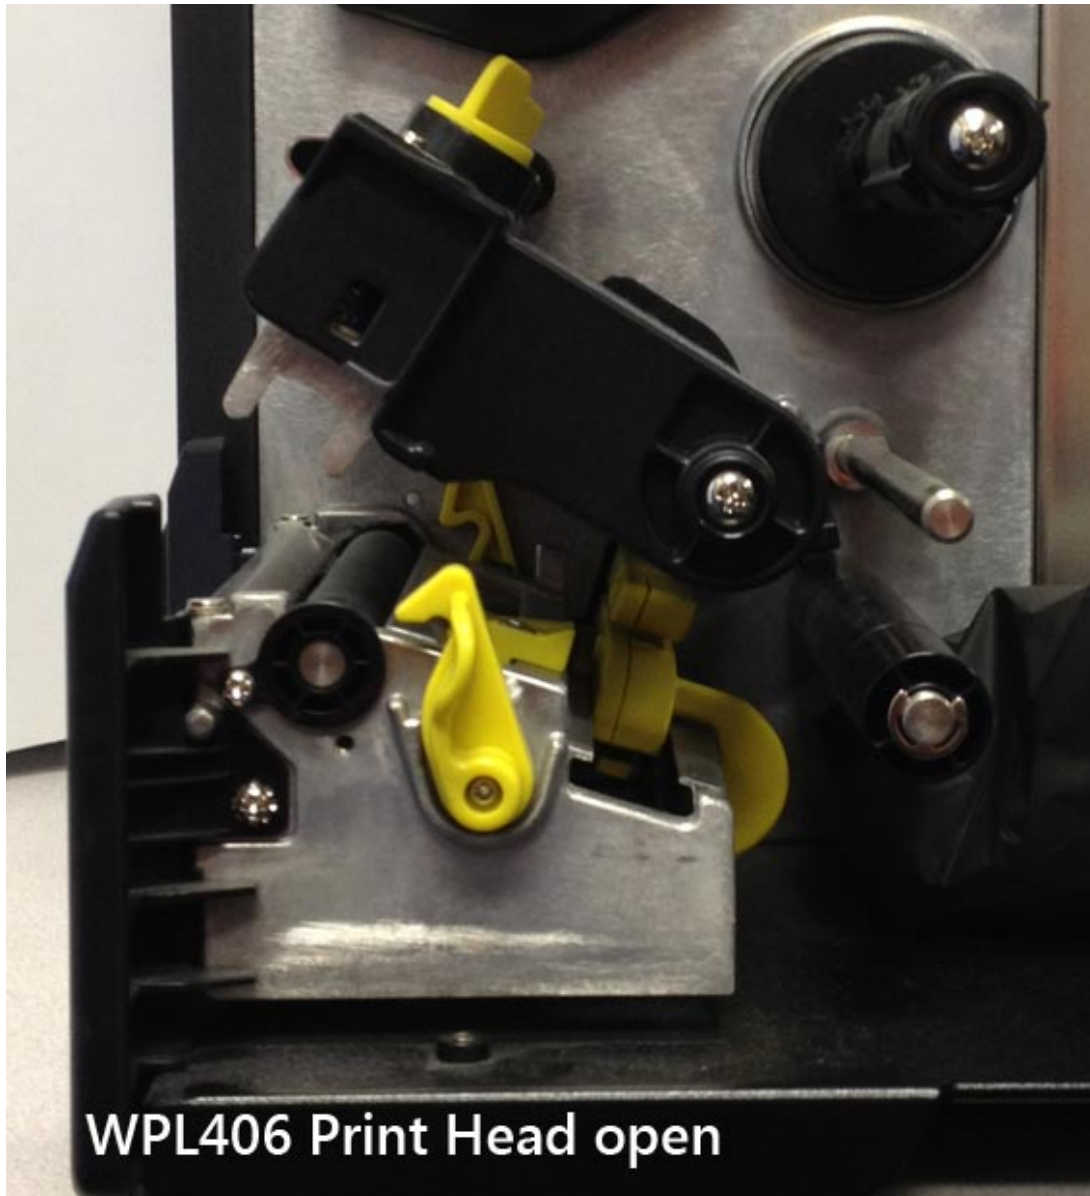
Close the print head completely before attempting to print. When the head is only partially closed, the yellow latch is nearly vertical. When completely closed, the latch is angled to the left. (See pictures below.)

Although the print head assembly has been closed and a "snap" sound is heard as it latches, it is only partially closed, resulting in improper pressure applied.

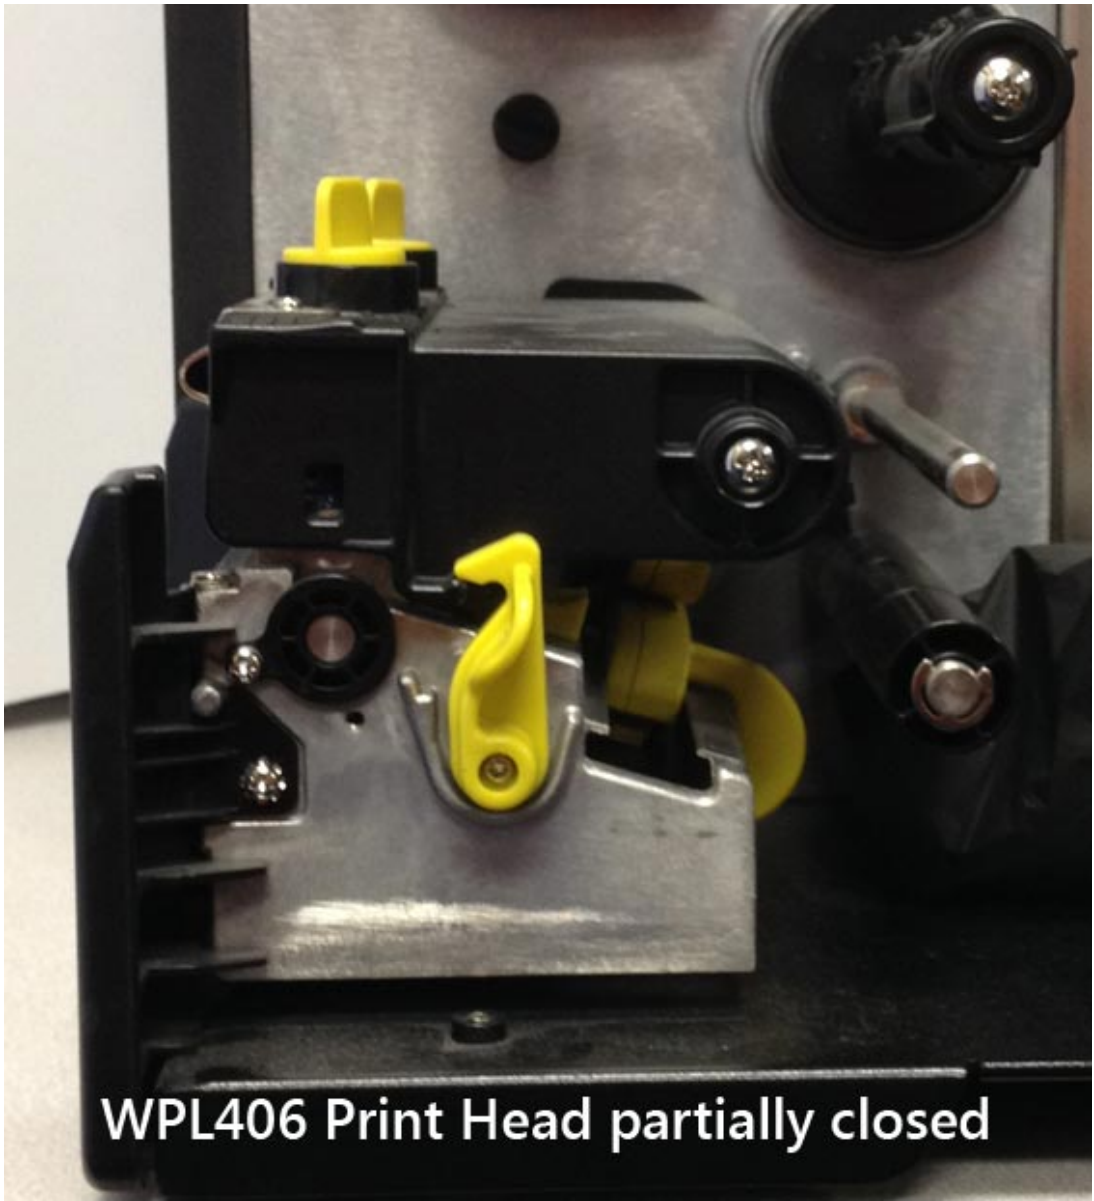
WPL406 Print Head partially closed

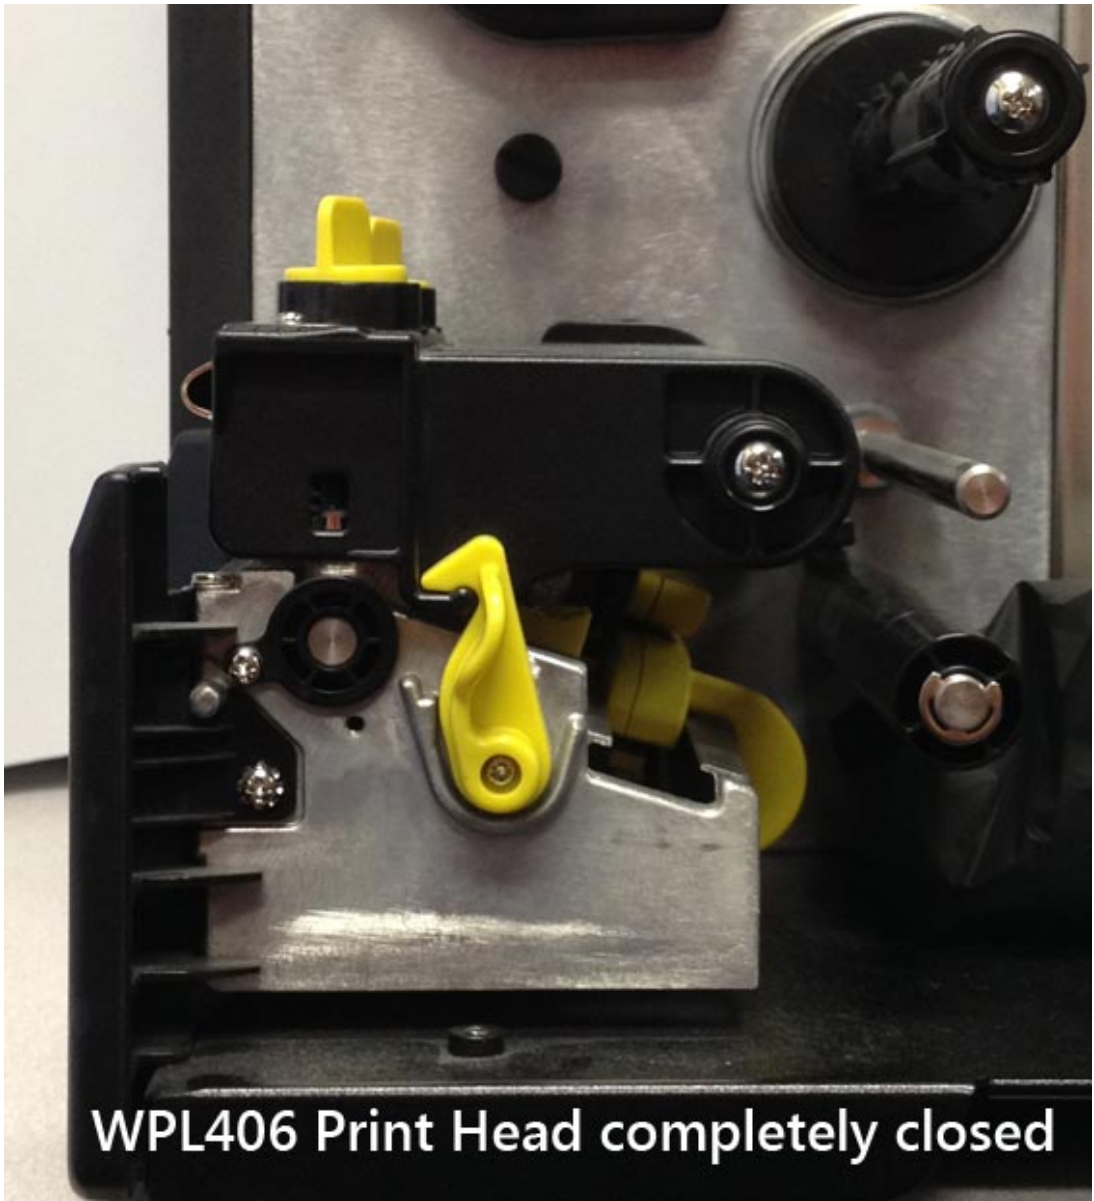
WPL406 Print Head completely closed
