Wasp

WPL406: label feed problems, grinding noise, print quality problems (print head not latched)

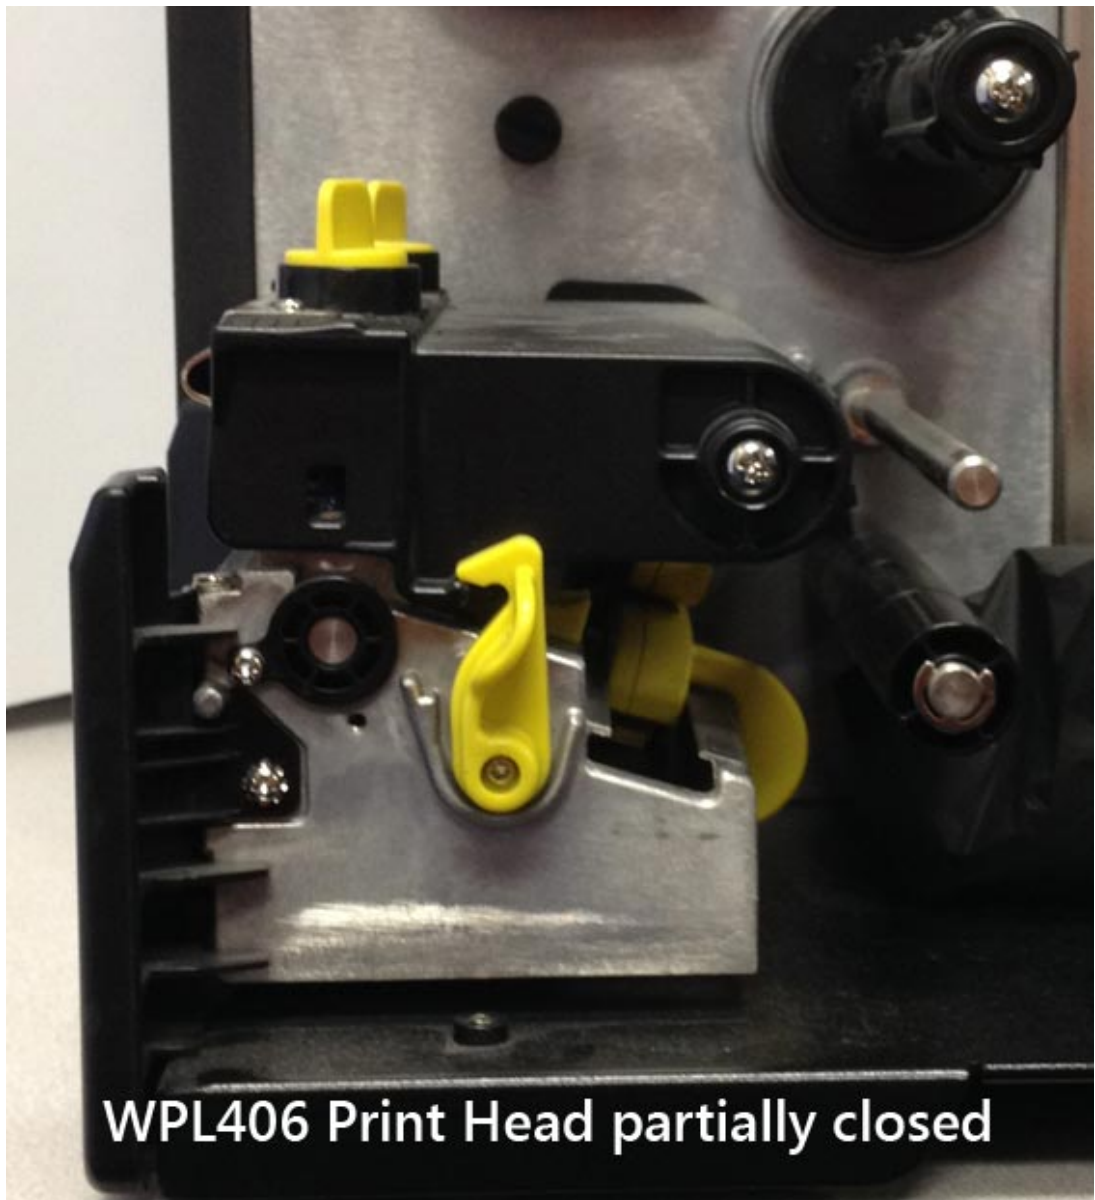
WPL406 Print Head partially closed

Close the print head completely before attempting to print. When the head is only partially closed, the yellow latch is nearly vertical. When completely closed, the latch is angled to the left. (See pictures below.)

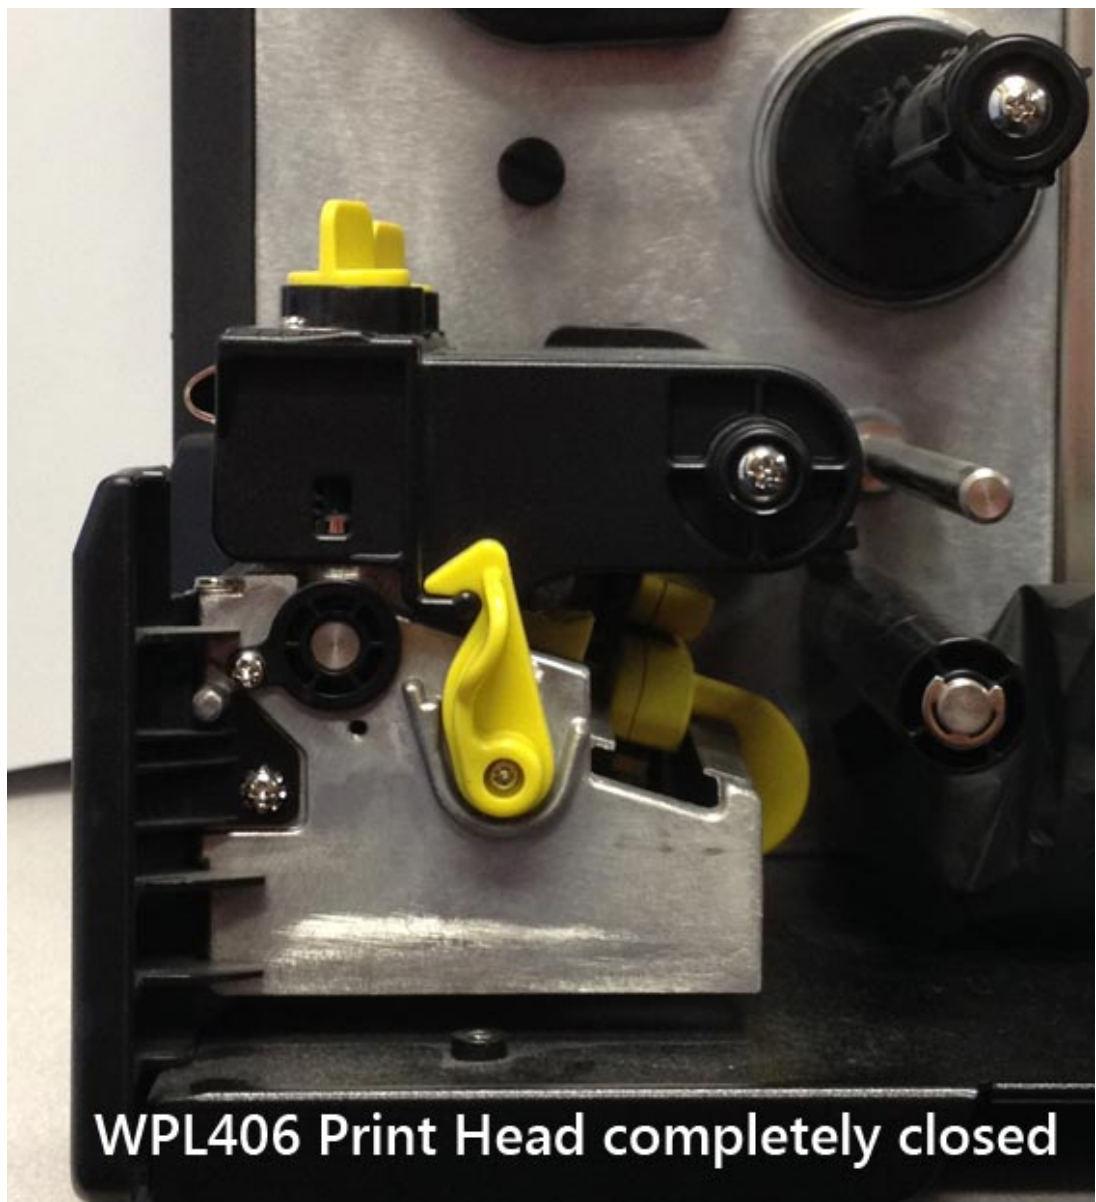
WPL406 Print Head completely closed
